CASE STUDY

Reduce Engine Failures and Cut Maintenance Costs on Haul Trucks

A MineCare customer shares how they protect haul truck engines and turbochargers from catastrophic failures with effective use of real-time data, avoiding \$750,000 in maintenance costs in just a few months time.

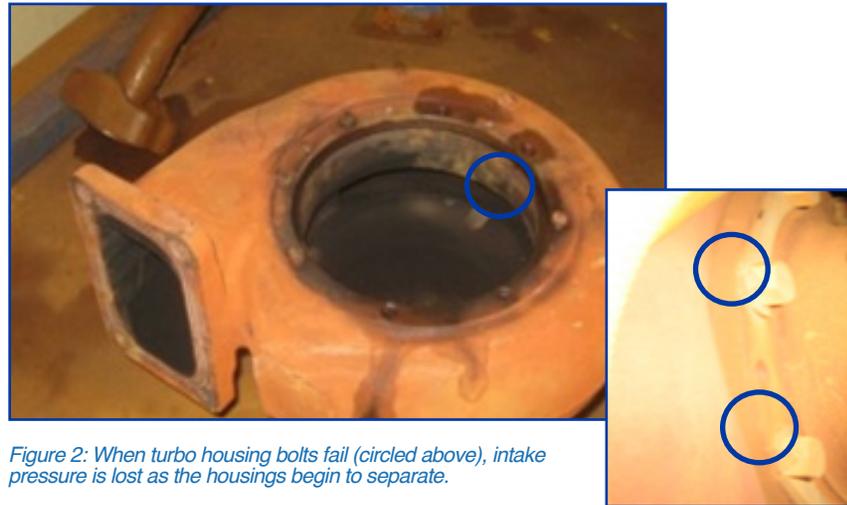
After the MineCare system signaled a low horsepower alarm, the maintenance team responded to find broken bolts on one of the haul truck's rear turbochargers. Consequently, the engine was shut down, preventing catastrophic failure and avoiding a potential cost of \$288,000 in maintenance repairs.

As a precaution, the truck was immediately shut down while the maintenance team analyzed the data sent to them by the MineCare attendant from a remote monitoring center. Using that data, the breakdown crew knew exactly where to look as they inspected the engine, quickly confirming that bolts had broken on the snail casing of the right-hand turbocharger. The casing had begun to separate from the turbine cover (Figure 2) resulting in a loss of horsepower.

Figure 2: When turbo housing bolts fail (circled above), intake pressure is lost as the housings begin to separate.

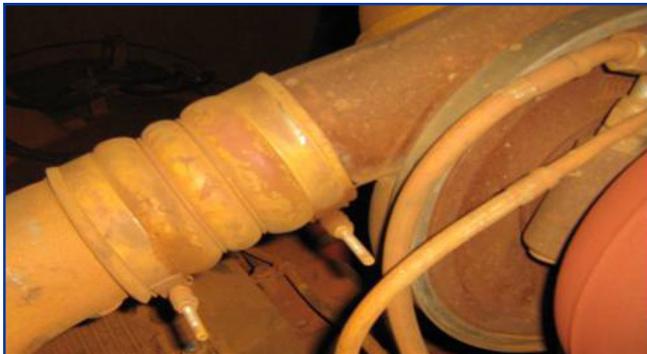
The breakdown crew found that a hose between the turbocharger and aftercooler had detached, preventing the compressed air from reaching the right bank of cylinders and elevating their temperatures. This leak also caused the original low boost pressure alarm. The breakdown crew fitted a new hose and clamp to the turbo-charger (Figure 5), and the truck was immediately sent back to work.

Figure 5: Example of the hose that detached from the turbocharger and aftercooler.

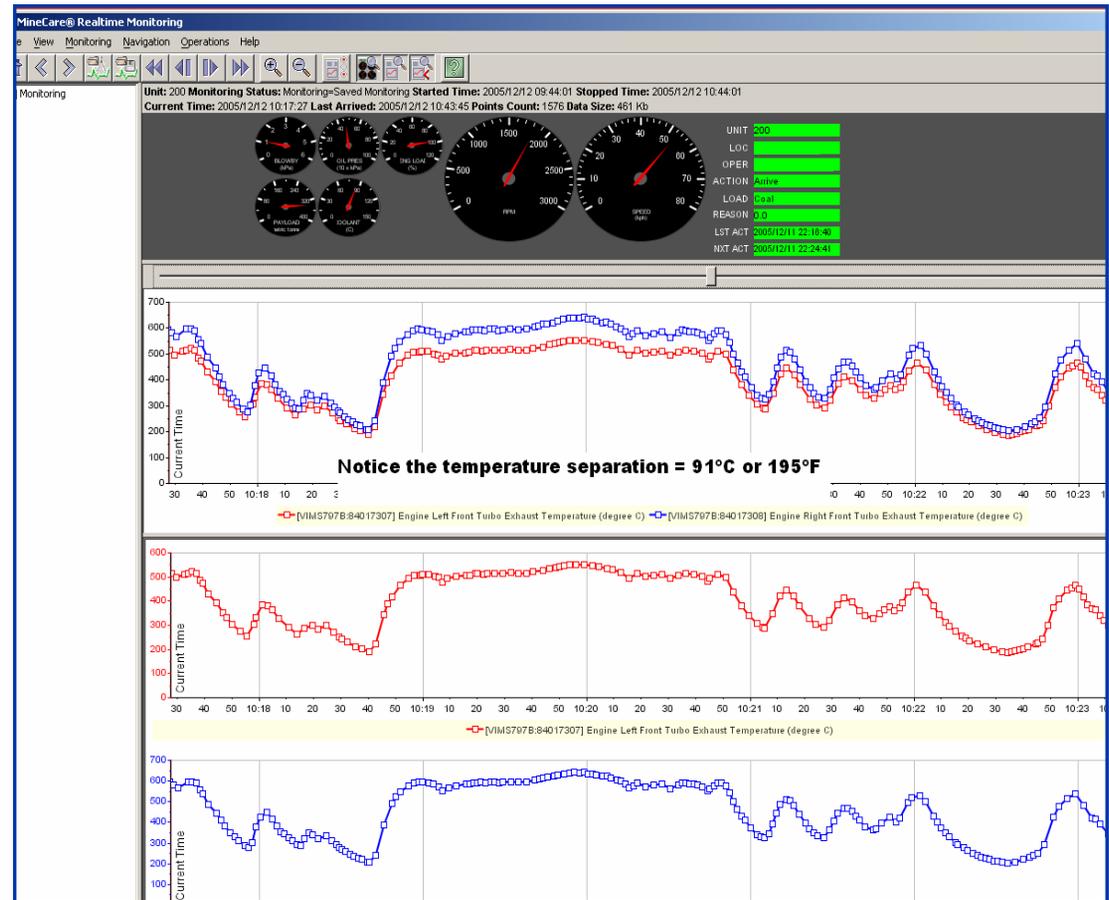
A similar defect related to boost air pressure was observed on another truck engine, and the RTM feature was used to validate the exhaust temperature. Figure 6 is shown below for comparison with Case 2, and for general informational purposes highlighting the capabilities of the MineCare system.

Figure 6: Example of how the MineCare system can be used to prevent a turbocharger defect by monitoring exhaust temperature differential.

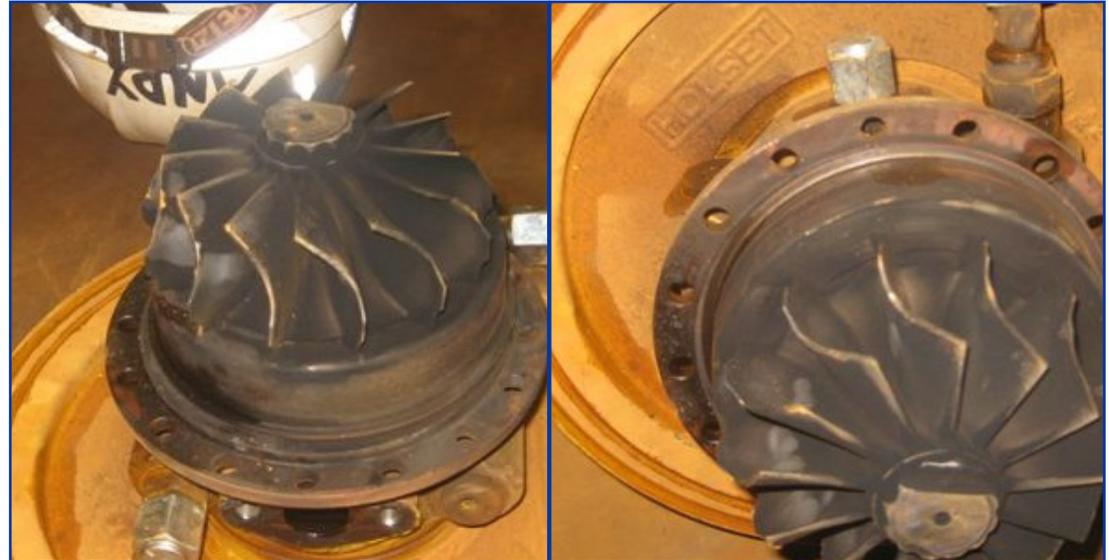
Upon analysis of the snapshot data, the MineCare system attendant requested the problem truck to park up in a safe place immediately. The breakdown crew found that the turbocharger had failed due to several bolt failures on the snail housing, causing the turbine vanes and the turbine housing to come into contact (Figure 7).

Figure 7: The dismantled turbocharger's turbine vanes are exposed, showing the damage they suffered during the incident.

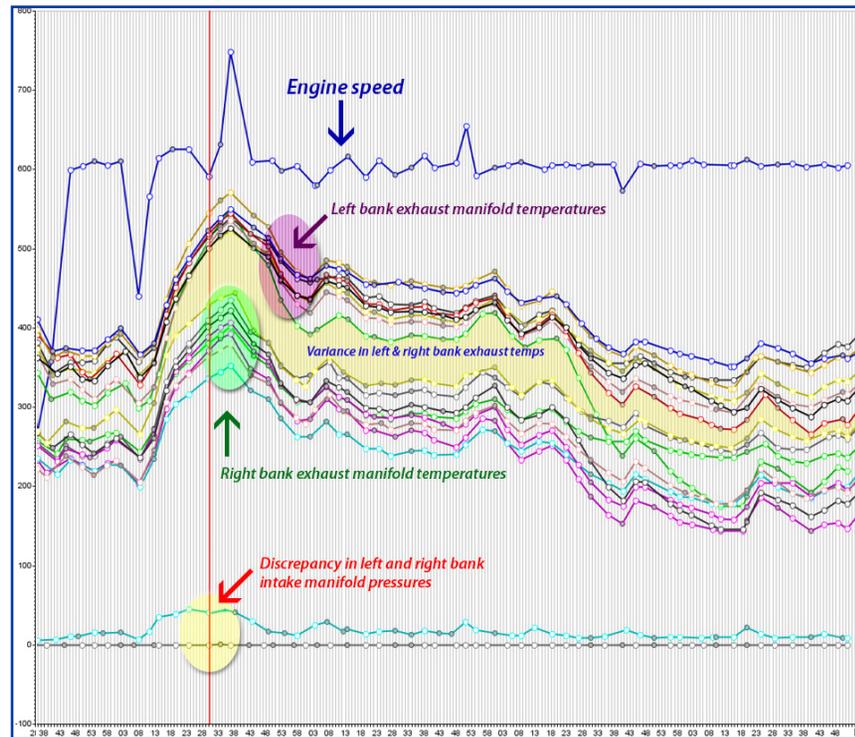
When the MineCare attendant received a low boost air pressure alarm from a haul truck engine, a real-time monitoring session was initiated to identify the fault by polling all the relevant engine parameters under load. A snapshot of parameters revealed low boost pressure from the left-hand intake manifold, and a distinct separation of the exhaust temperatures between the left- and right-hand exhaust manifolds. The MineCare attendant immediately questioned the operator about the truck's performance, and the operator indicated a brief loss of power. A nearby operator simultaneously reported smoke coming from the problem truck's exhaust.

The snapshot captured by the mine's maintenance team (Figure 8), displays left and right bank exhaust temperatures with the difference between them shaded in yellow. Purple and green colored ovals highlight the two different groups of exhaust temperatures. Similarly, the yellow circle near the X-axis highlights the difference in boost air pressure of each side of the intake manifold.

Figure 8: Snapshot of exhaust temperature and intake manifold pressure differential. The gap between right and left bank exhaust is highlighted in yellow.
